SERVICE BULLETIN

AUGUST 1995

GO-KART DEFLECTOR UPDATE

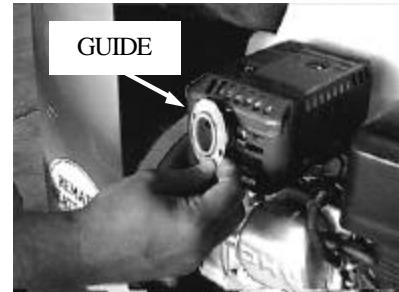
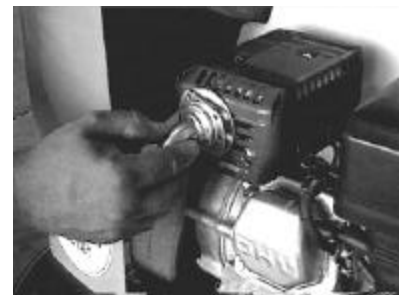
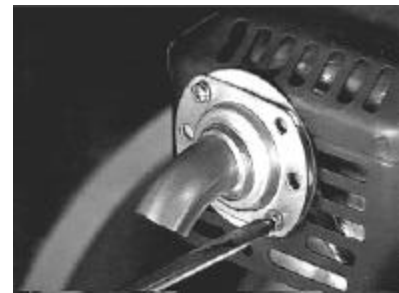
Excessive heat between muffler and protective shield causing fuel tank to get soft and may rupture.

Missing Guide.

Install Guide as seen in picture.

Guide, Muffler **Part#34407320**
