# SERVICE BULLETIN

KART-0006

## FLY BY WIRE (KART REMOTE SYSTEM)

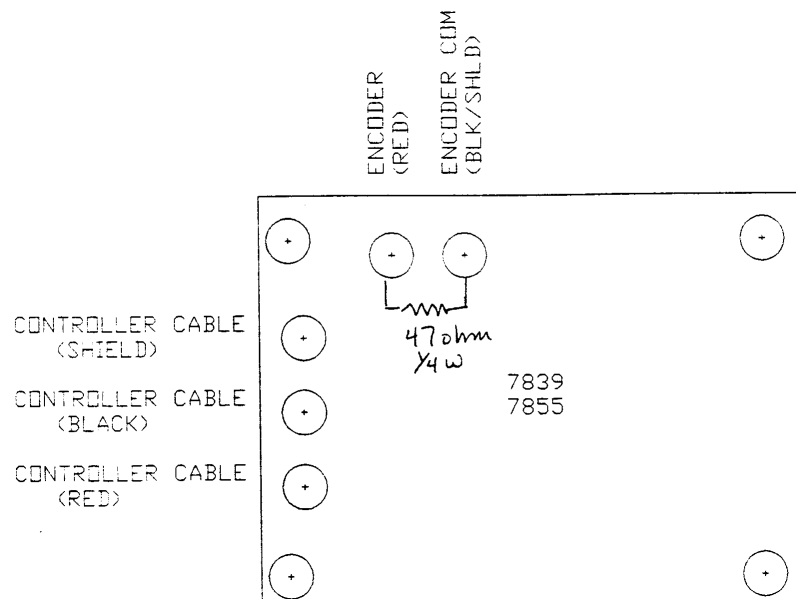
**SOME CUSTOMERS ARE REPORTING THAT THE SPEED ADJUSTMENT CAN BE SOMEWHAT ERRATIC. THIS IS CAUSED BY THE ENCODER PUTTING OUT TOO MANY PULSES. IT IS ONLY NOTICEABLE ON A FEW KARTS, BUT CAN BE SOLVED BY PUTTING A 47 ohm 1/4 w RESISTOR ACROSS THE ENCODER. RESISTORS WILL BE INCLUDED WITH THIS**
