SERVICE BULLETIN

Thunder-01

Thunder Bolt Roof Update

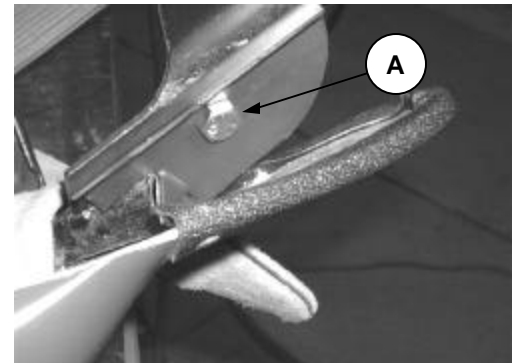
Excessive vibration causing roof hinge mount to crack.

STEP 1: Bolt retro bracket to roof mount as seen in picture above.
