SERVICE BULLETIN

February 9, 1996

Thunder-02

Trim Update

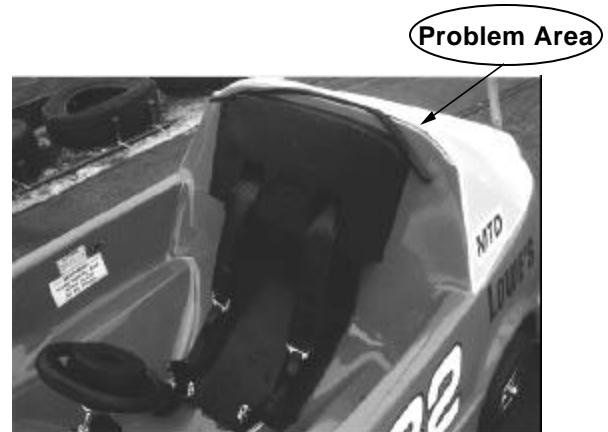
Trim, Self Adhesive ThunderBolt Roof **Part#002677A**

Movement of roof causing roof trim to pull away from body.

Install new trim.
