J&J Amusements, Inc.

SERVICE BULLETIN

GO-KART # 3

AFFECTED UNIT- 1993 Black Frame Single and Double Seater GoKarts.

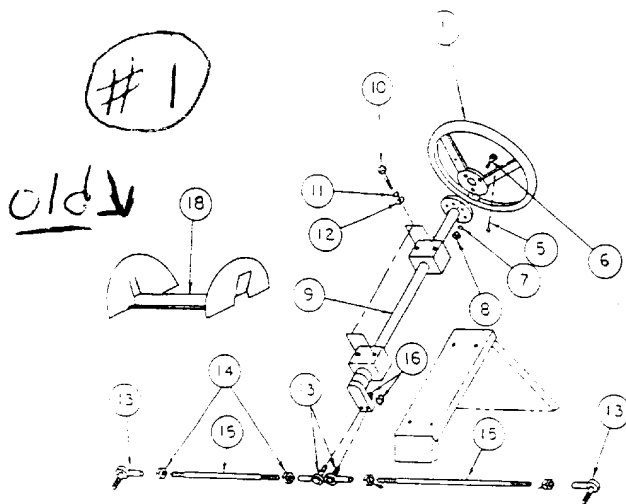
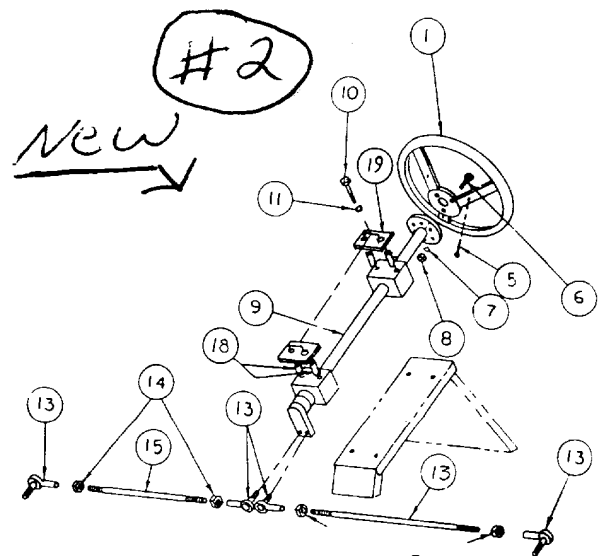
REASON FOR UPDATE- The bolts that hold the steering shaft are working loose resulting in poor handling of the gokart and/or breakage of the bolts.

CORRECTIVE ACTION- Install new steering shaft and hardware. Follow the installation instruction below.

1. Remove steering wheel (#1) from old steering shaft.
2. Remove steering cover (#18).
3. Remove nuts (#16), then remove tie rod ends (#13) from steering shaft.
4. Remove bolts (#10) and washers (#11 & 12). Next remove old steering shaft.
5. Install the updated steering shaft with the new hardware supplied (See Diagram #2) in the reverse order.

NOTE: USE RED THREAD LOCK ON BOLTS (#10) WHEN INSTALLING.
